# Combining historical and geological data for the assessment of the landslide hazard: a case study from Campania, Italy

D. Calcaterra<sup>1</sup>, M. Parise<sup>2</sup>, and B. Palma<sup>3</sup>

Abstract. Past slope instabilities at Quindici (one of the five towns of Campania that was hit by catastrophic landslides on 5 May 1998) and in the Lauro Valley are investigated to improve the understanding of the landslide history in the area, as a mandatory step for the evaluation of the landslide hazard. The research was performed by combining information on past slope instabilities from both historical and geological data. From numerous historical sources an archive consisting of 45 landsliding and flooding events for the period 1632–1998 was compiled. Landslide activity was also investigated by means of interpretation of multi-year sets of aerial photos, production of Landslide Activity Maps, and excavation of trenches on the alluvial fans at the mountain foothills. Detailed stratigraphic analysis of the sections exposed in the trenches identified landslide events as the main geomorphic process responsible for building up the fans in the study area. Integration of historical and geo

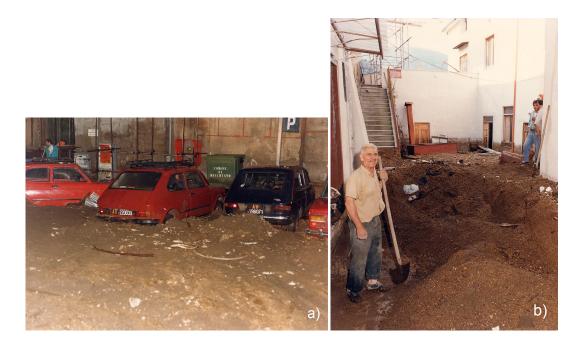
Fig. 3. Effects of the 27 August 1990 flood at Moschiano (photos by courtesy of Moschiano Municipality). On that occasion 30.8 mm of rainfall occurred in about one hour, and several roads (a) and some private houses (b) were blocked by some decimetres of muddy debris.

After this first phase of research, our study moved towards analysis of information available in books, documents and works of a more local interest. Several interviews with the local authorities were carried out, and the documents available at the Municipal Technical Offices at Quindici, Lauro and Moschiano, and at *Comunità Montana "Vallo di Lauro e Baianese"* (a local management agency, of intermediate rank between the central government and municipalities) were examined. Despite detailed research, again a very small amount of data with temporal reference was collected (4 events; see Table 1). However, good documentation, including several photographs (Fig. 3), was found for the three most recent events.

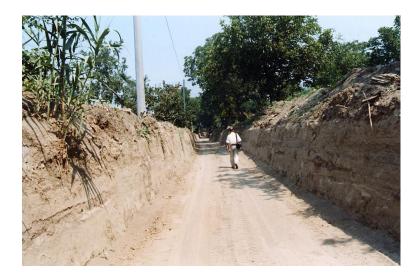
Fig. 4. One of the many channels ("Regi Lagni") built by Bourbon Kings in the 18th century to facilitate flow of water and mud from the frequent flood and landsliding events (photo taken in July 1998). The channel (some 3.5 m wide and 2 m deep) was completely filled at the time of the 5 May event, and had been used until that time by local farmers to have access to the fields by car: for this reason it was called an "alveo-strada" (channel-road). The network of channels at Quindici and in the Lauro Valley was cleared in 1998 a few days after the landslides had already hit the inhabited areas.

Construction of an extensive and complex network of channels, termed the Regi Lagni (Fig. 4), was started in the 16th century under the Spanish Viceroyalty and completed in 18th century by the Bourbon Kings. It covered an extension of several hundreds of square kilometres, from the lower slopes of Mt. Pizzo d'Alvano and Mt. Somma-Vesuvius, through the Volturno River plain, to the Tyrrhenian Sea. However, the inadequacy of the Regi Lagni was underlined by the repeated floods which occurred at Quindici and in the Lauro Valley during the 19th century. Many technical reports refer to severe damages suffered by Regi Lagni, including destruction of a number of check dams (locally called "catene", i.e. chains) by floods or landslides. At that time, cleaning of the channels, which had filled with sediment to a depth of several metres, was an urgent necessity. Debris was removed with teams of buffalo, their passage (locally termed as "mena delle bufale") allowing for the finer fraction of the deposits to be re-suspended and washed away (Aversano, 2000).

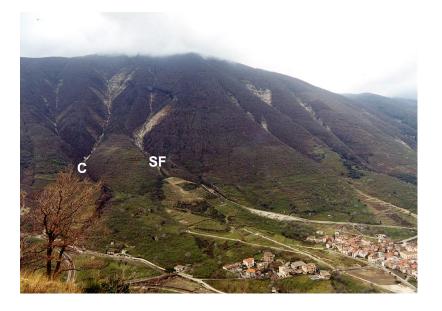
**Fig. 6.** Overall view of Mt. Pizzo d'Alvano upslope from Quindici (photo taken in March 2001): to the left of the photo, the landslides in the two gulles of Connola Valley (C) and in S. Francesco Valley (SF) are clearly visible. Note the smooth morphology of the fans at the mouth of the valleys, and especially that at the mouth of S. Francesco Valley. Some of the recently made remedial works are visible in the photo.

The most striking geomorphological features in the Quindici area are a number of fans (Figs. 5 and 6) which have built up in the upper Lauro Valley, including the site where most of the town of Quindici lies (Brancaccio et al., 1999; Calcaterra et al., 1999). Several generations of fans were initially identified from aerial photographs. Comparable fans have recently been described in nearby areas, including the Clanio and Acqualonga Torrents near Avella and Baiano, some five kilometres north from Quindici (Di Vito et al., 1998).
