## Historical data anlysis of landsliding and flood events in Campania (Italy), as a tool for the assessment of the landslide hazard

# Combining historical and geological data for the assessment of the landslide hazard: a case study from Campania, Italy

D. Calcaterra<sup>1</sup>, M. Parise<sup>2</sup>, and B. Palma<sup>3</sup>

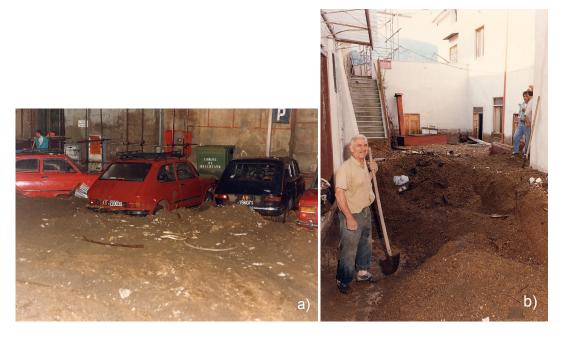
**Fig. 3.** Effects of the 27 August 1990 flood at Moschiano (photos by courtesy of Moschiano Municipality). On that occasion 30.8 mm of rainfall occurred in about one hour, and several roads (a) and some private houses (b) were blocked by some decimetres of muddy debris.

After this first phase of research, our study moved towards analysis of information available in books, documents and works of a more local interest. Several interviews with the local authorities were carried out, and the documents available at the Municipal Technical Offices at Quindici, Lauro and Moschiano, and at *Comunità Montana "Vallo di Lauro e Baianese"* (a local management agency, of intermediate rank between the central government and municipalities) were examined. Despite detailed research, again a very small amount of data with temporal reference was collected (4 events; see Table 1). However, good documentation, including several photographs (Fig. 3), was found for the three most recent events.

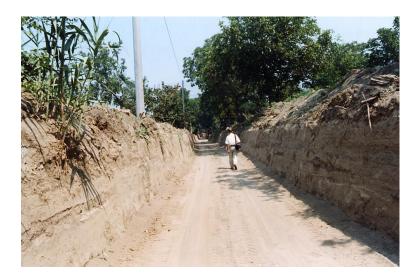
Fig. 4. One of the many channels ("Regi Lagni") built by Bourbon Kings in the 18th century to facilitate flow of water and mud from the frequent flood and landsliding events (photo taken in July 1998). The channel (some 3.5 m wide and 2 m deep) was completely filled at the time of the 5 May event, and had been used until that time by local farmers to have access to the fields by car: for this reason it was called an "alveo-strada" (channel-road). The network of channels at Quindici and in the Lauro Valley was cleared in 1998 a few days after the landslides had already hit the inhabited areas.

Construction of an extensive and complex network of channels, termed the Regi Lagni (Fig. 4), was started in the 16th century under the Spanish Viceroyalty and completed in 18th century by the Bourbon Kings. It covered an extension of several hundreds of square kilometres, from the lower slopes of Mt. Pizzo d'Alvano and Mt. Somma-Vesuvius, through the Volturno River plain, to the Tyrrhenian Sea. However, the inadequacy of the Regi Lagni was underlined by the repeated floods which occurred at Quindici and in the Lauro Valley during the 19th century. Many technical reports refer to severe damages suffered by Regi Lagni, including destruction of a number of check dams (locally called "catene", i.e. chains) by floods or landslides. At that time, cleaning of the channels, which had filled with sediment to a depth of several metres, was an urgent necessity. Debris was removed with teams of buffalo, their passage (locally termed as "mena delle bufale") allowing for the finer fraction of the deposits to be re-suspended and washed away (Aversano, 2000).

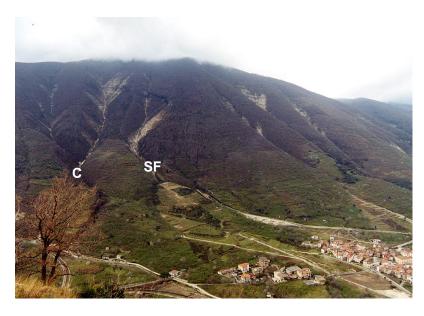
Fig. 6. Overall view of Mt. Pizzo d'Alvano upslope from Quindici (photo taken in March 2001): to the left of the photo, the landslides in the two gullies of Connola Valley (C) and in S. Francesco Valley (SF) are clearly visible. Note the smooth morphology of the fans at the mouth of the valleys, and especially that at the mouth of S. Francesco Valley. Some of the recently made remedial works are visible in the photo.

The most striking geomorphological features in the Quindici area are a number of fans (Figs. 5 and 6) which have built up in the upper Lauro Valley, including the site where most of the town of Quindici lies (Brancaccio et al., 1999; Calcaterra et al., 1999). Several generations of fans were initially identified from aerial photographs. Comparable fans have recently been described in nearby areas, including the Clanio and Ac-

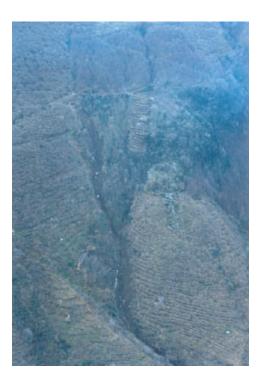
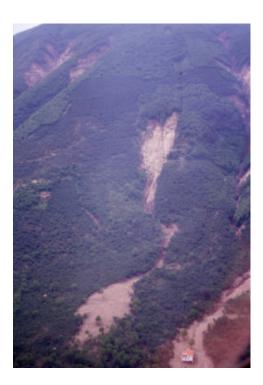
**Fig. 10.** Comparison from 1997 to 1998 of the main landslides in Lagno Cisierno: the photo at left was taken by A. Santo (University of Naples) on 24 January 1997, few days after the 1997 event; photo at right was taken in June 1998, about one month after the May tragic event. Note the different extent of the area affected by landsliding, and in particular the enlargement of the main landslide area toward the west (to the right in the photos).

Comparison of terrestrial photographs was also performed for some of the slope failures on the northern slopes of Mt. Pizzo d'Alvano, for which photos shot soon after the January 1997 landsliding event were available (Fig. 10). The comparison showed that in some cases the landslides triggered during the 1998 event were enlargements of slope failures which occurred 16 months earlier. This has very im-
