Restoration projects and remedial works in the historical island of Ventotene

N. Bosco Civil Engineer – Ventotene (LT)

P. Croce DICeM - University of Cassino and Southern Lazio

ABSTRACT: Ventotene is a very small island in the Mediterranean sea and yet a very remarkable natural and historic site. In fact the peculiar volcanic nature of the island and the ruins of the Roman Empire are joined together as a single and unique jewel, which attracts enthusiastic visitors from all over the world. However, the island is subjected to the continuous dismantling action of the natural agents, which cause an accelerated sequence of erosive phenomena and landslides. This peculiar process, which is progressively reducing the dimension of the island, is undermining the stability of monuments and ruins and has recently determined several collapses including some casualties. The paper examines the case of Ventotene by considering several interconnected topics: the geological nature of the island, the characteristics of its monuments and ruins, the geotechnical properties of the volcanic deposits, the erosive process, the typical landslides mechanisms. Particular attention is given to the search f

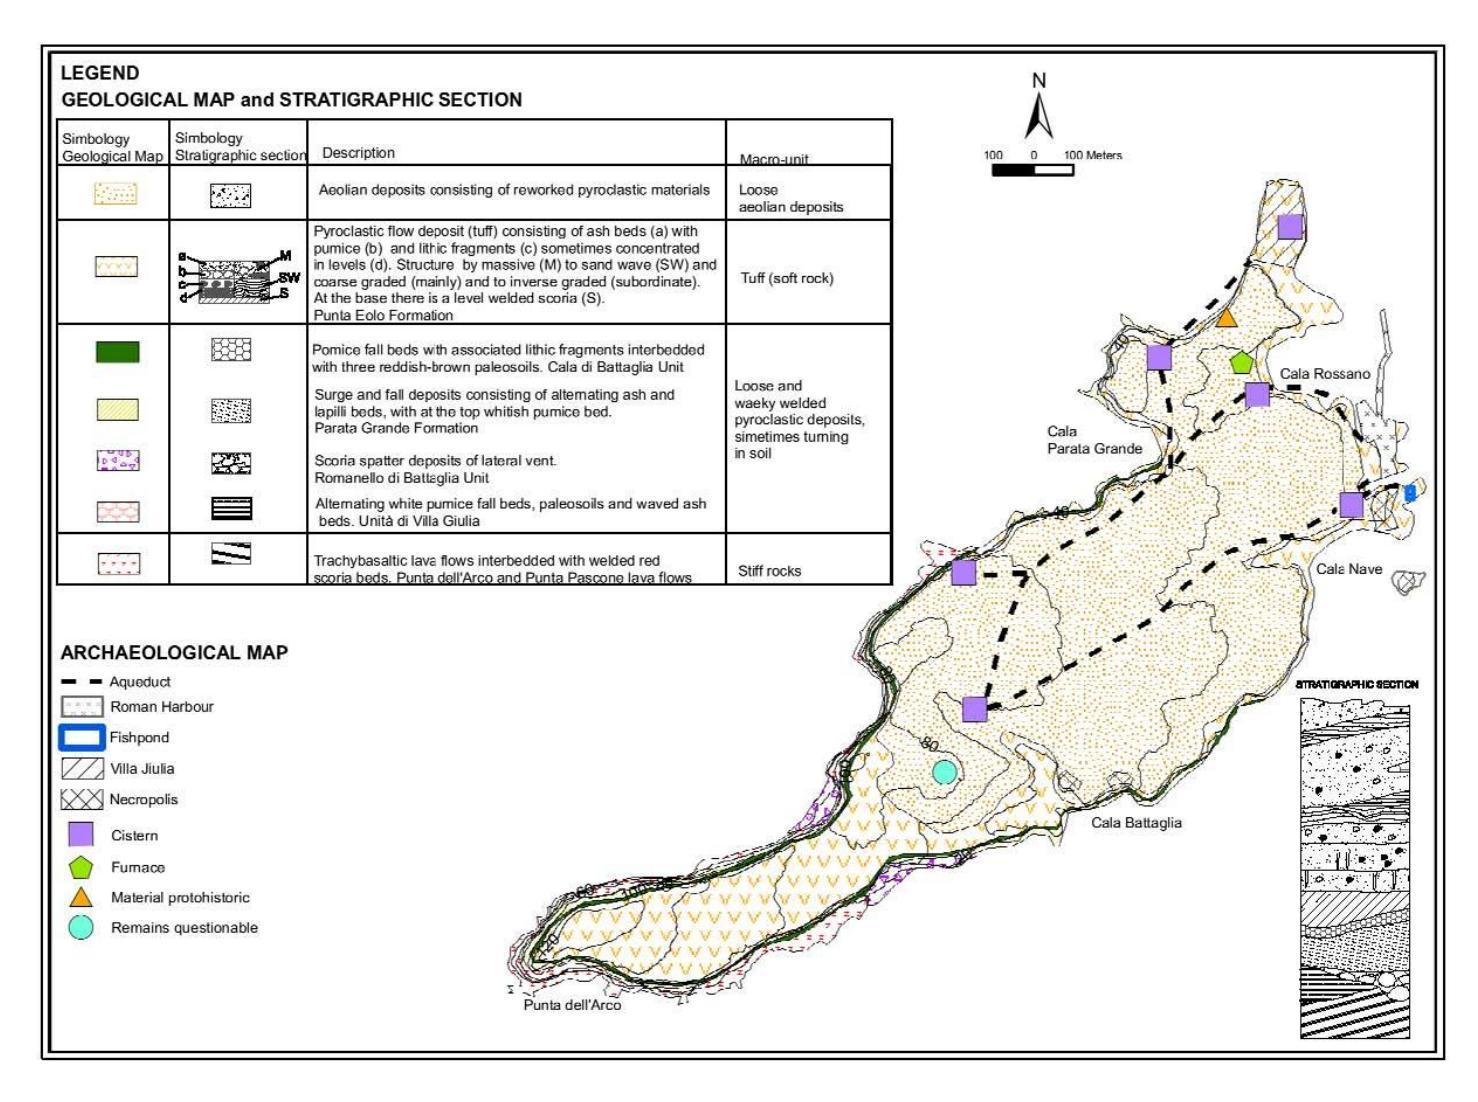
Figure 1. Geological and Archeological map of Ventotene (Bellucci et alii, 1999 mod).

Nowadays the surface of the island is 1.24 km^2 and its maximum dimensions are: length 2.7 km, width 0.85 km, height = 135 m above sea level. The land of the island is relatively flat but its borders are made of very steep cliffs with the exception of the north-eastern corner, which has provided the access to the island throughout its history (Fig. 1).

The geological formations of the island can be grouped in four main lithological units (Fig. 1):

The aeolian deposits, resting on top of the tuff, are subjected to small earth slides (Varnes 1978; Cruden and Varnes 1996) occurring mainly along the coastal perimeter between Cala Battaglia and Punta Pascone through Cala Rossano (see Fig. 1). These earth landslides are favoured by the rain water which operates both by infiltration and scouring, producing grooves and funnels which may act as triggering points. The sliding surfaces are often located along the weaker contact surfaces between the primary pyroclastic deposits and the natural soil (Palma et alii, 2009).

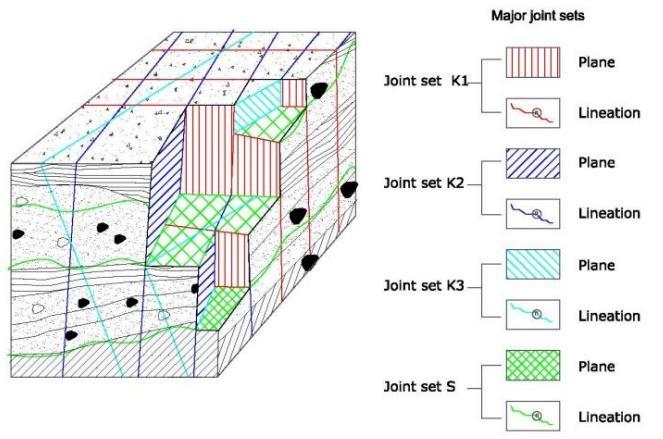
Figure 2. Schematic view of the discontinuities in the pyroclastic rocks.

The rock slides are diffused along the entire perimeter of the island, taking place mostly in the tuff formation with mechanisms of toppling and sliding (Varnes 1978, Cruden and Varnes 1996). These mechanisms are dictated by the sub-vertical weak planes related to cooling joints formed in the ignimbrite deposits after their emplacement. Such weak planes give rise to three principal families (k1, k2, k3) of discontinuities with dip direction of 35° (k1), 250° (k2) e 200° (k3) (Fig. 2). The single block volumes are in order of few cubic meters but the whole landslide volumes can become to hundreds of cubic meters (Fig.3).

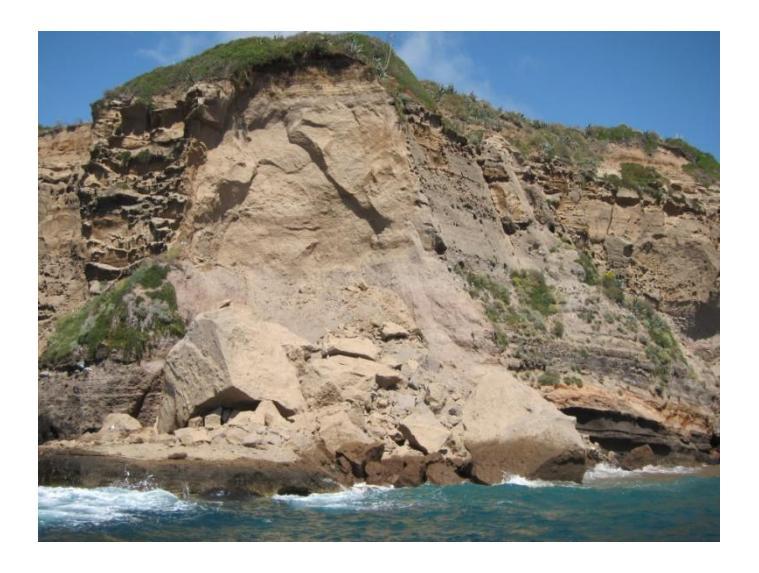
Figure 3. Typical landslide of a tufaceous cliff (Parata Grande).

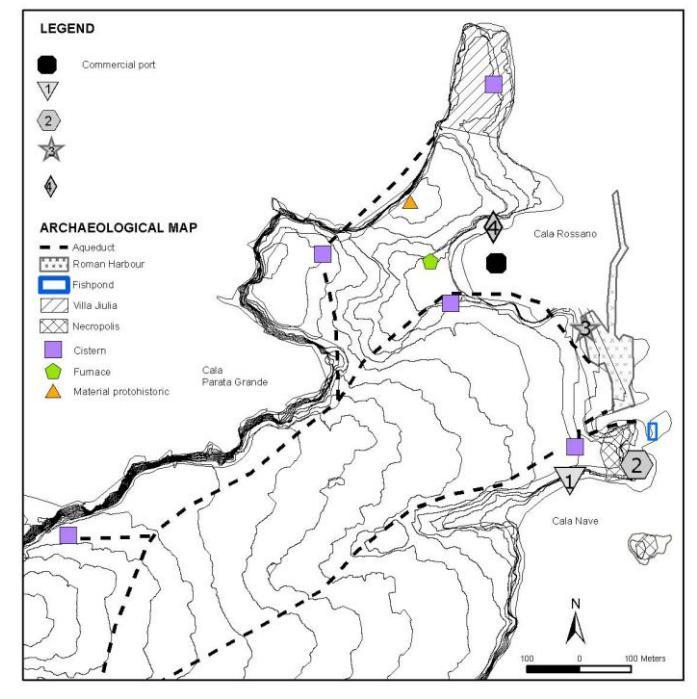
Figure 4. Slope stabilization and protection projects: 1) stabilization of the rock cliff above Cala Nave beach; 2) stabilization of the rock cliff under a Roman necropolis; 3) restoration of the ancient Roman Harbour; 4) stabilization and rock fall protection at Cala Rossano commercial harbour.

However, by comparing the wide extension of the natural hazards with the reasonable economical resources, it was first recognized that is not possible to stop the natural erosion process and to provide effective slope stabilization all over the island. It was then decided to identify the most valuable areas which can be effectively protected within economical availability. It was thus determined to concentrate the efforts in the north-eastern sector of the island, which is the most important from any point of view. In fact, as it was previously mentioned, this area provides the only access to the entire island, by means of two harbours, one close to the other: the ancient roman harbour and the new commercial port for the ferryboats. Moreover, the most valuable historical buildings and archaeological ruins are concentrated in this zone, as well as the most popular beaches. Four main projects were thus planned in this area as indicated in Fig. 4.

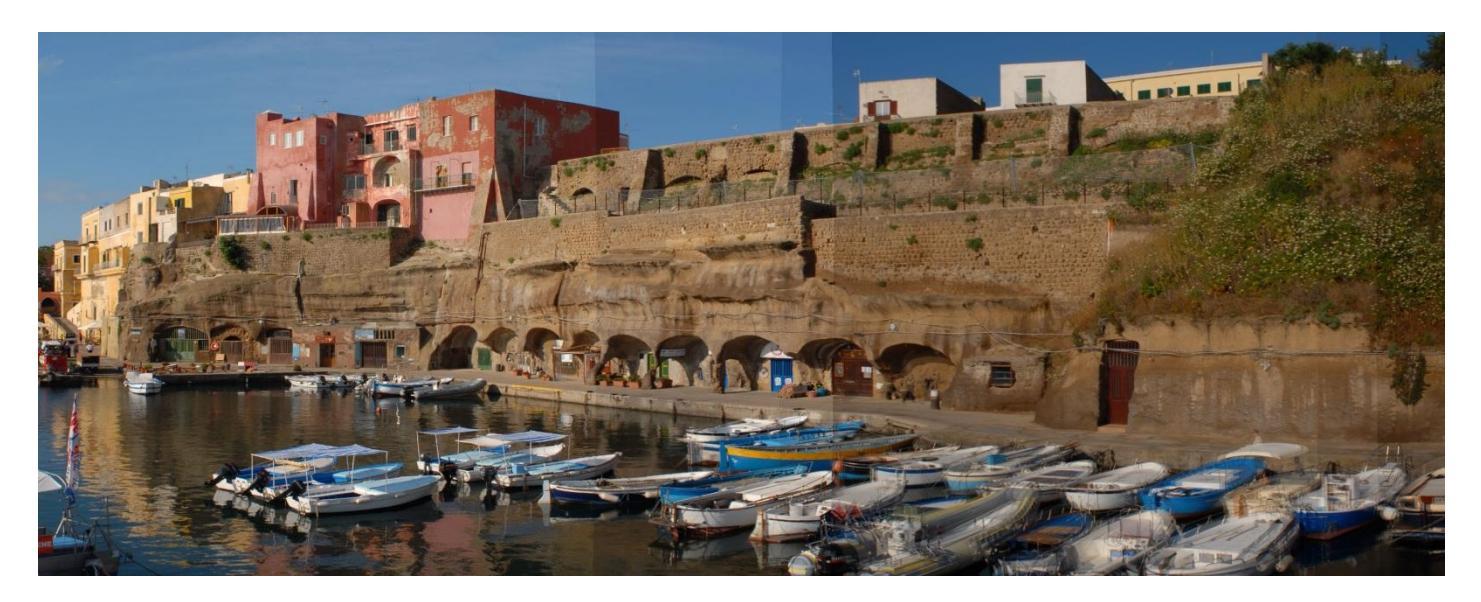
Figure 5. Global view of the Roman Harbour.

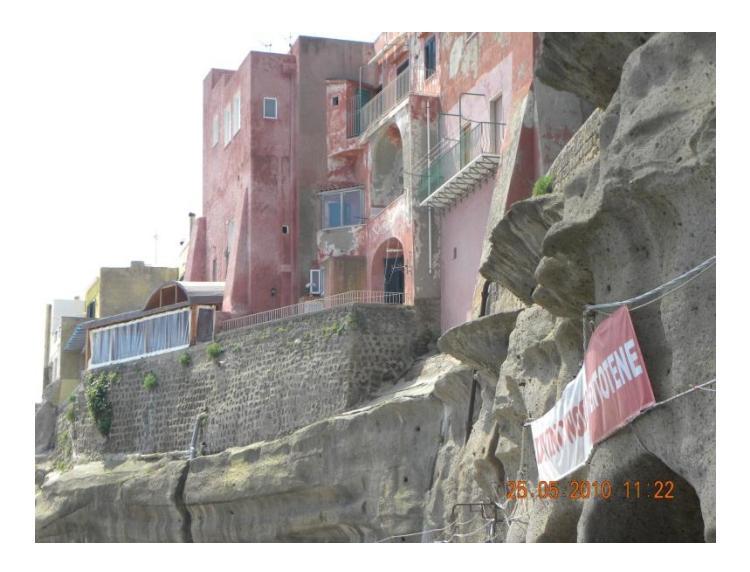
Figure 6. Tuff cliff, natural slabs and 18^{th} century buildings before restoration works.

The tuff surface has then been grooved by the wind erosive action over the centuries, giving rise to some characteristic natural rock slabs overhanging the dock with a span of about $2\div3$ m (Fig. 6). The upper portion of the cliff is characterized by the presence of some old retaining walls, dating back to the Bourbons period (18th century), made of weakly cemented tuff masonry. The latter, which are up 6 m high, provide static support to some layers of pyroclastic soils and made land resting on top of the tuff (Fig. 7).

Inspections carried out on the cliff showed the good conditions of the tuff shelves and verified that there were no evidence of cracks or discontinuities. Therefore it was decided to avoid invasive remedial works and to perform a shallow cleaning of the shelves removing soil, vegetation and altered elements corresponding to the thinner breakable parts on the edges. Furthermore, in order to prevent the erosive action by the atmospheric agents, the tuff surface was treated by spray application of acrylic polymer in aqueous dispersion, able to increase the abrasion resistance without altering the wall natural aspect.

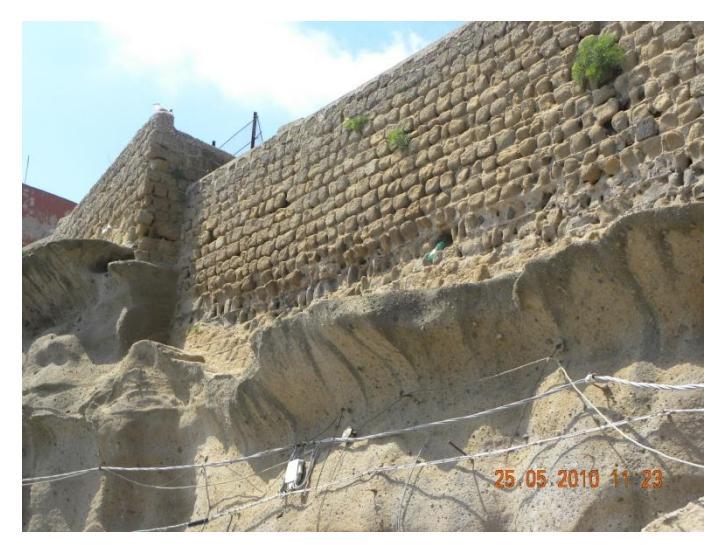
Figure 7. Masonry wall at the top of the cliff before restoration works.

One of the most critical problem was due to the inadequate strength of the old masonry retaining walls at the top of the cliff. In fact it was recognized that it was not possible to provide effective structural strengthening to the existing walls.

However it was also considered that a new structure would have altered the architectural characteristics of the harbour. It was thus decided to improve the mechanical characteristics of the by soil at the backside of the wall, in a zone with thickness ranging from 1.2 to 1.5 m. Such soil improvement was provided by deep mixing, which was carried on by using customized light equipment, achieving columns having 200 mm diameter (Papa and Ramondini, 2011 & 2012). After the grout curing, the treated soil acquired compressive strengths comparable to those of a weak concrete

Following soil improvement, the old retaining tuff walls now act as a sort of coating, subjected only to its self weight and possible seismic actions. However, the walls were studded with 1.5 m long steel bars, designed to anchor the masonry in the grouted soil behind the wall. On the front face of the wall a special structural plastering, armed with FRP (Fyber Reinforced Polymer) grid was installed to ensure high protection and durability against the corrosive action of the aggressive sea environment. The work section is sketched in Fig. 13.

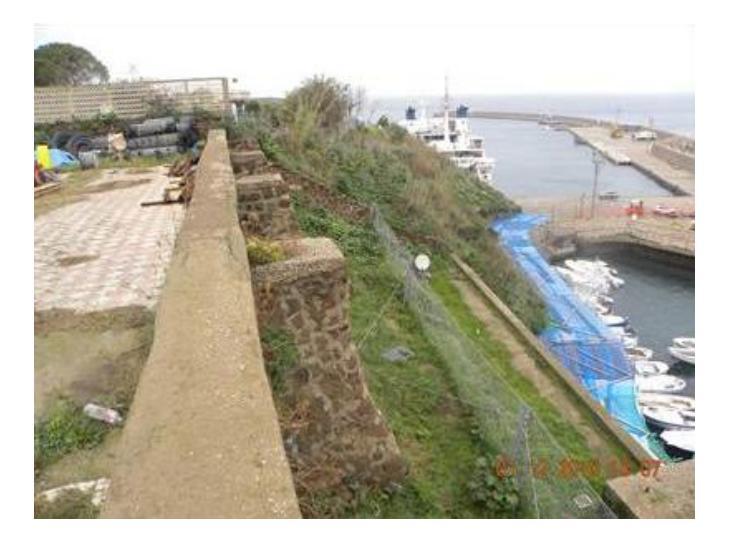
Finally, on top of the cliff there exist several masonry buildings constructed by the Bourbons, belonging to the old "*Granili*" barracks. These barracks were partly demolished during the works done in the last century, shortly before the second world war, leaving only the parade ground which is used today as a public terrace (Fig. 8).

Figure 8. Side view of the Roman and the commercial harbours from the "*Granili*" terrace, during the restoration works.

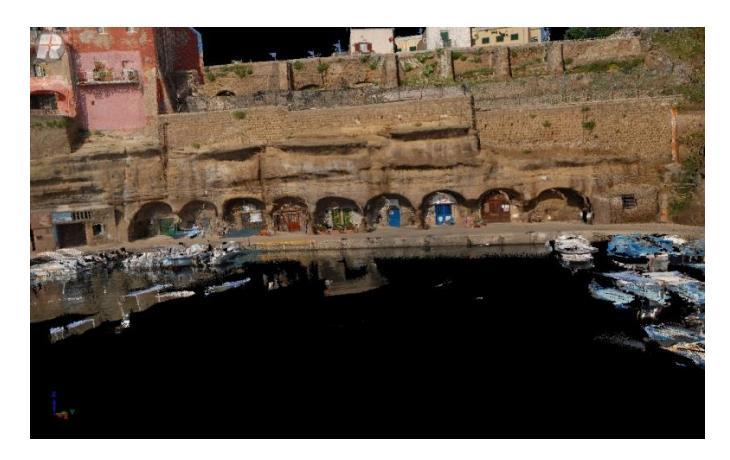
As it was previously explained, the overall design was developed not only to achieve appropriate safety factors, for both the natural tuff cliff and the preexisting retaining walls, but also with the purpose of preserving the complex historical landscape. Therefore a detailed survey of the harbour area was preliminarily provided by means of three-dimensional laser scanning (Fig. 9) in order to document in an objective way the conditions of the premises prior to restoration, thus securing the faithful recovery of the historical complex.

Figure 9. 3D laser scanner survey of dock, caves, cliff and masonry of the Roman harbour before the restoration works (courtesy of Idrogeo s.r.l.).

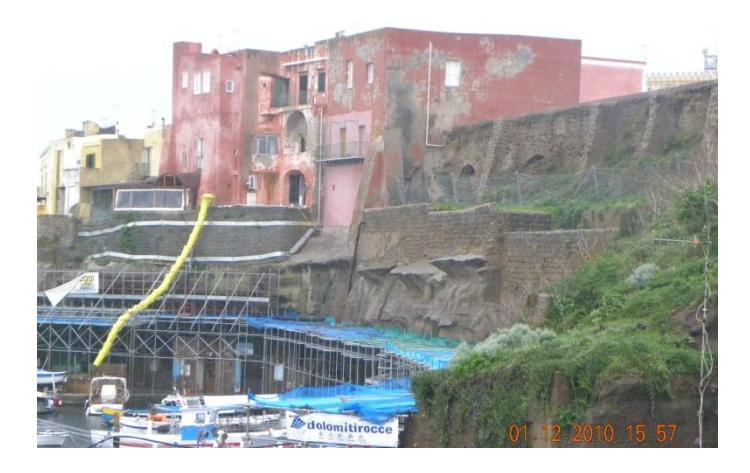
Figure 10. View of the yard area and provisional steel structure over the dock.

For this purpose a provisional steel structure was placed all over the dock to ensure full protection during the works (Fig. 10).

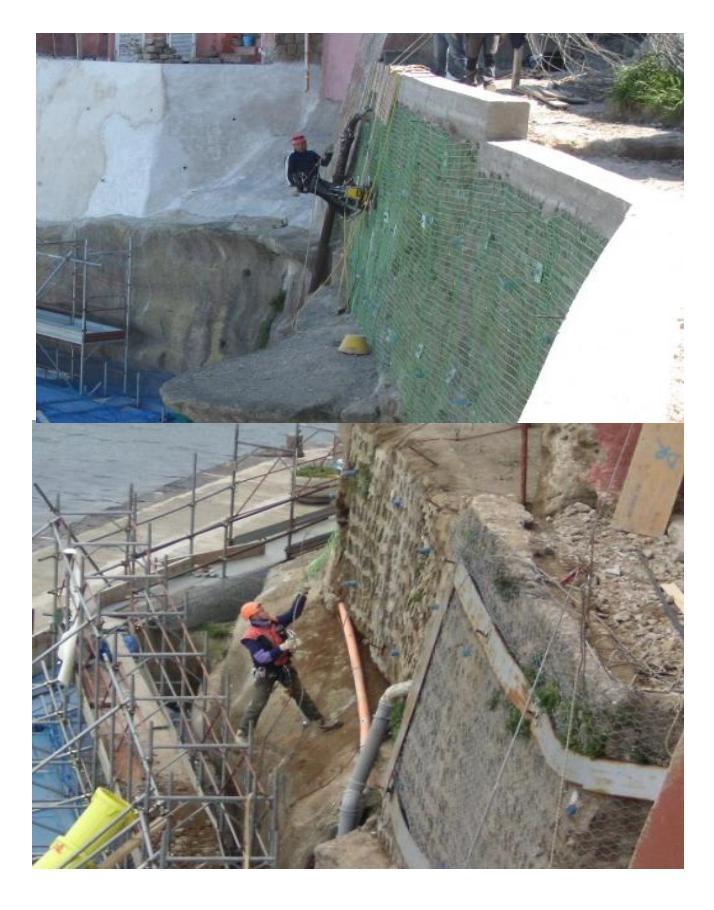
Figure 11. Climber workers on the cliff.

Due to the morphology of the area it was necessary to operate with unusual techniques. In particular specialized climber workers, operating for the most part in rope were employed (Fig. 11), and small size manageable equipment was used (Fig. 12).

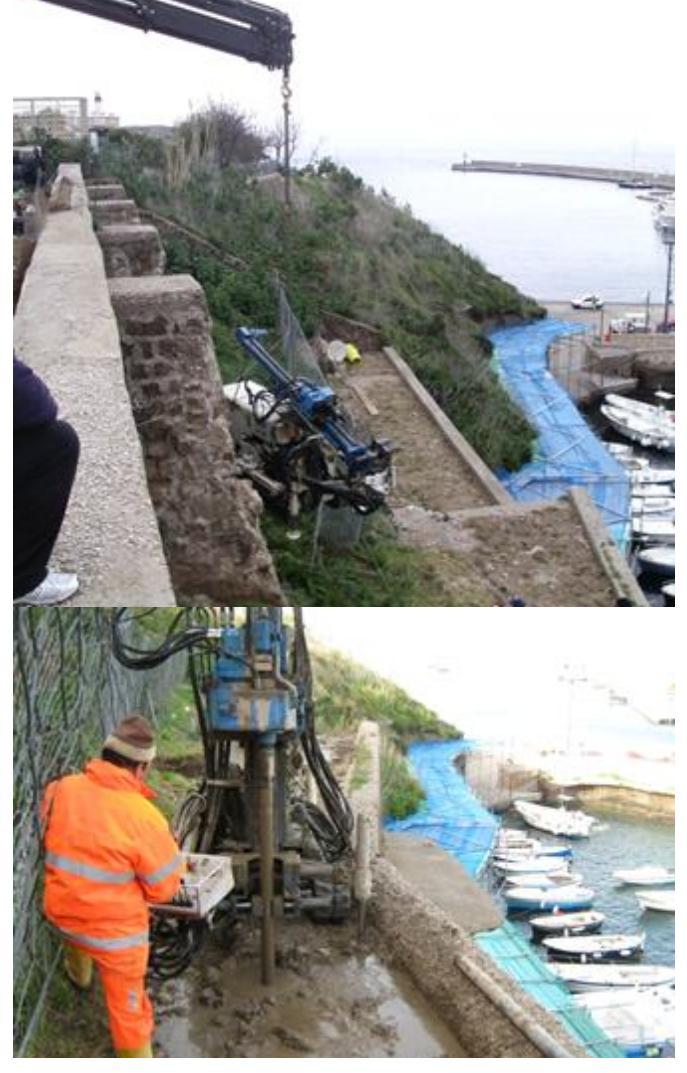
Figure 12. Drilling rig for deep mixing at the top of the cliff.

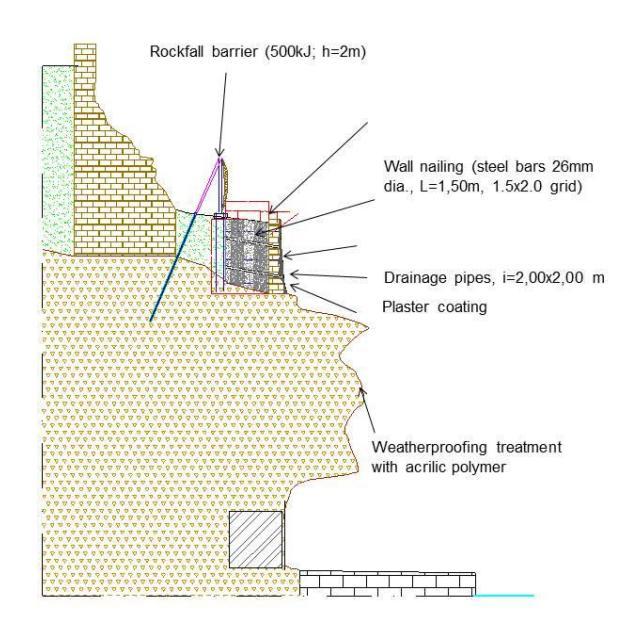
Figure 13. Schematic section of the restoration works (courtesy of Idrogeo s.r.l.).

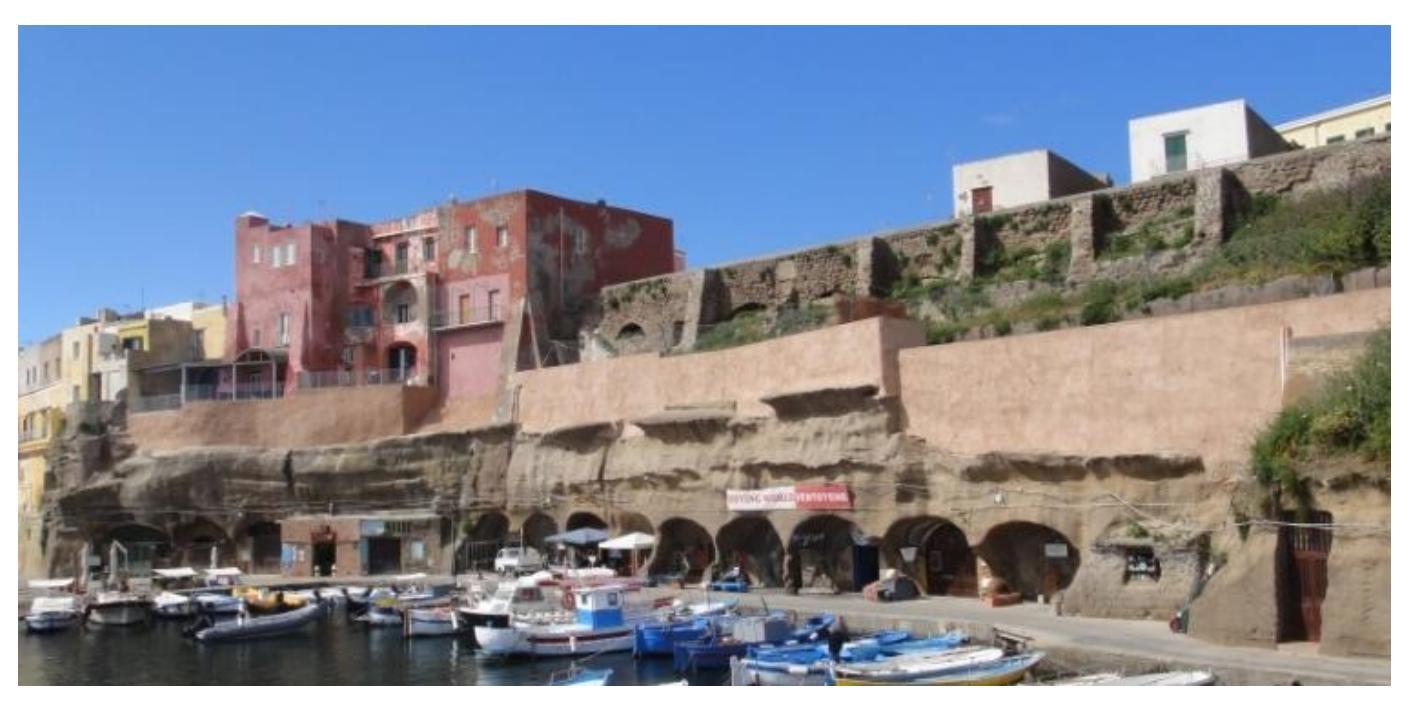
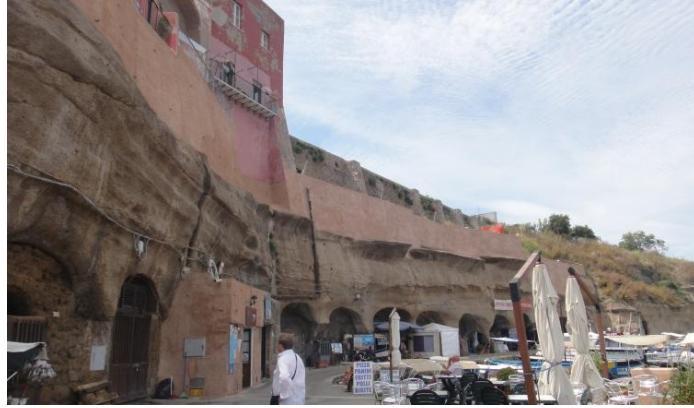
Figure 14. Roman harbour area after the restoration works.

The final arrangement has revived the original plaster coating of the Burbon walls (Fig. 14).
