# LANDSLIDE SUSCEPTIBILITY MAPS IN THE ROCK SLOPES OF THE VENTOTENE ISLAND (LATIUM, ITALY)

**I. Caso<sup>1</sup>, R. D'Angelo<sup>1</sup>, B. Palma<sup>1</sup>, M. Parise<sup>2</sup>, A. Ruocco<sup>1</sup>**

<sup>1</sup> IdroGeo srl, Vico Equense, Italy

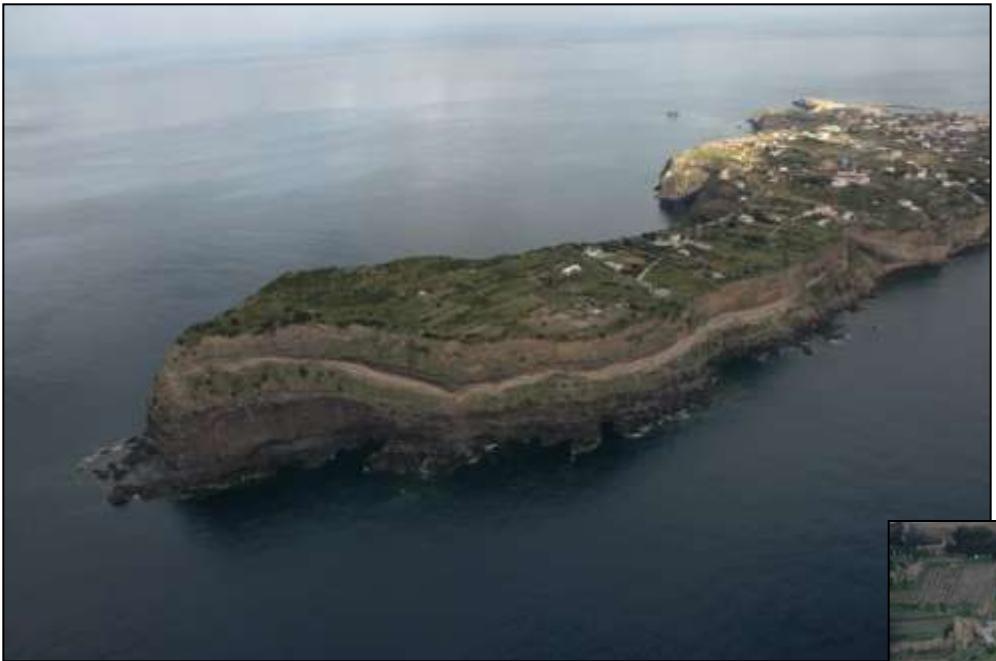
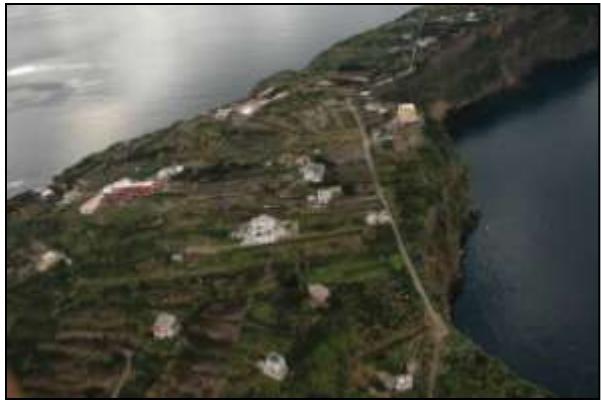
Cliffs from 130 m (southern sector) to 10 m (northern sector) high

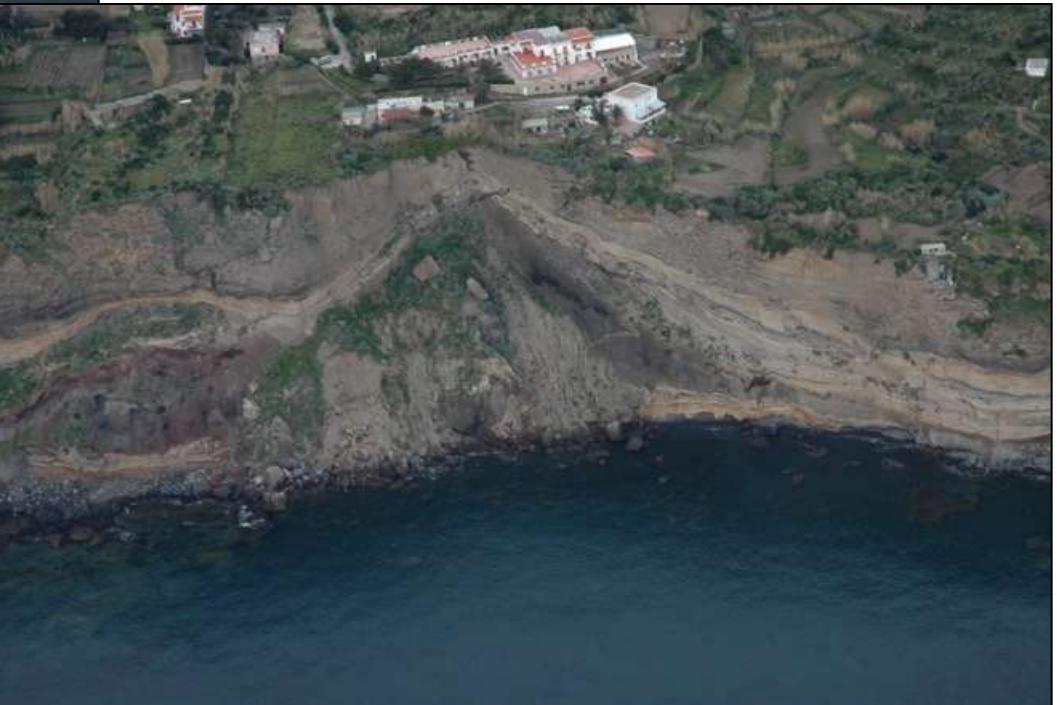
Evidence of instability along the coasts

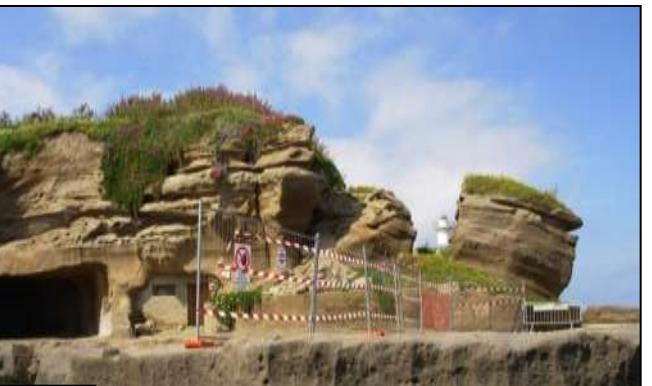
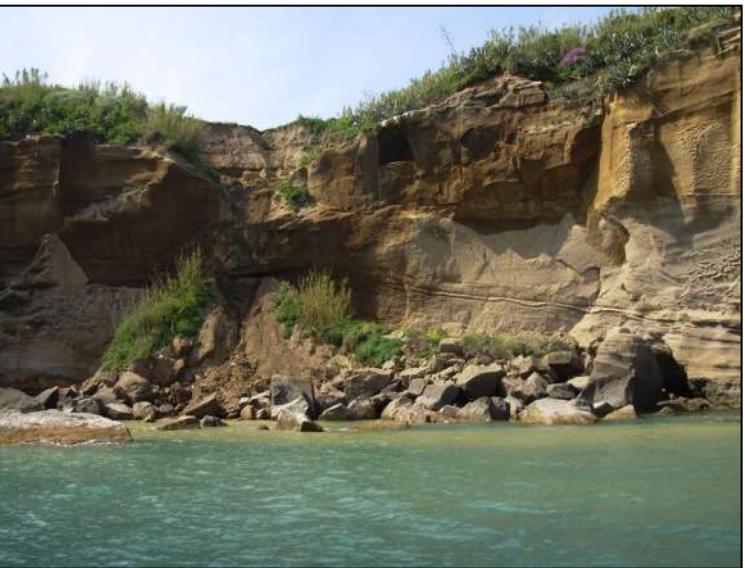
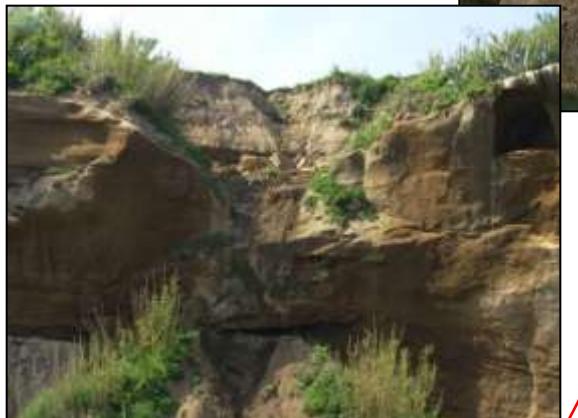
Open cracks

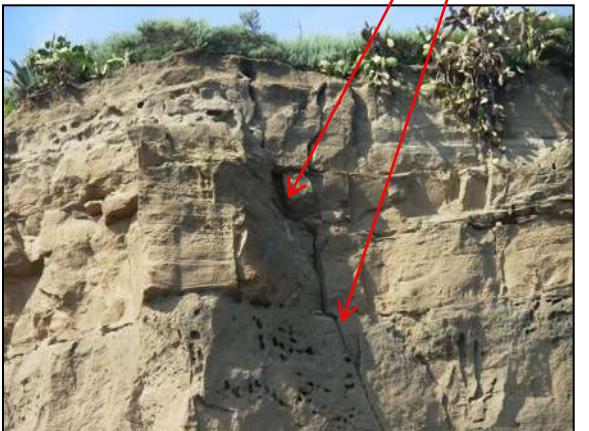
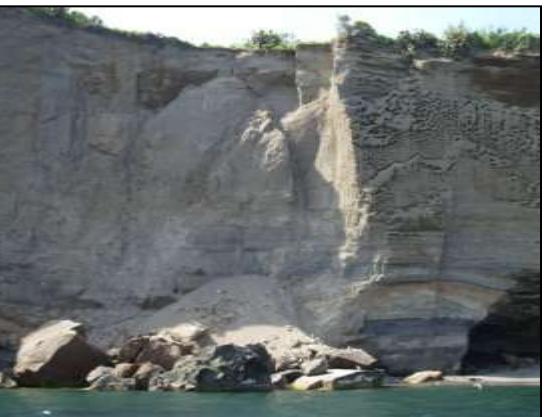
Open cracks

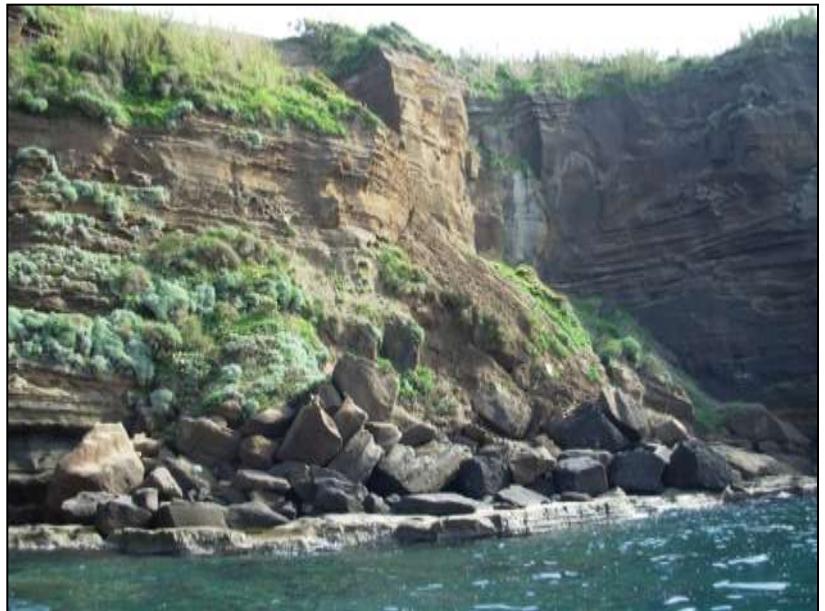
Landslide deposits at the base of a cliff

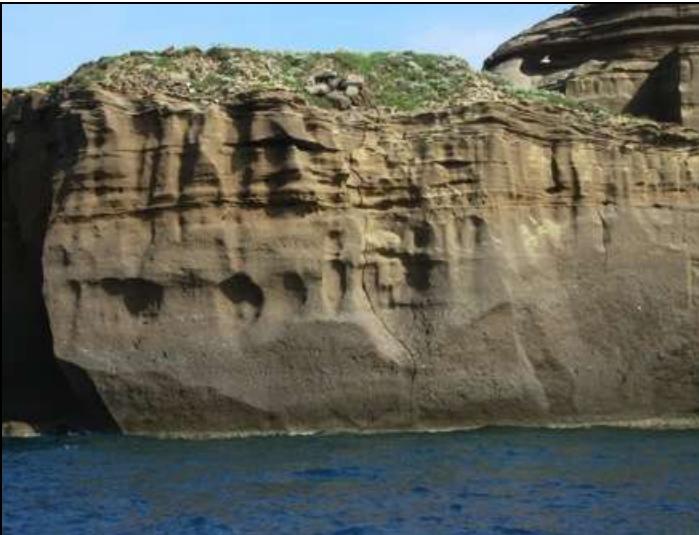
Extensive cracks along a cliff

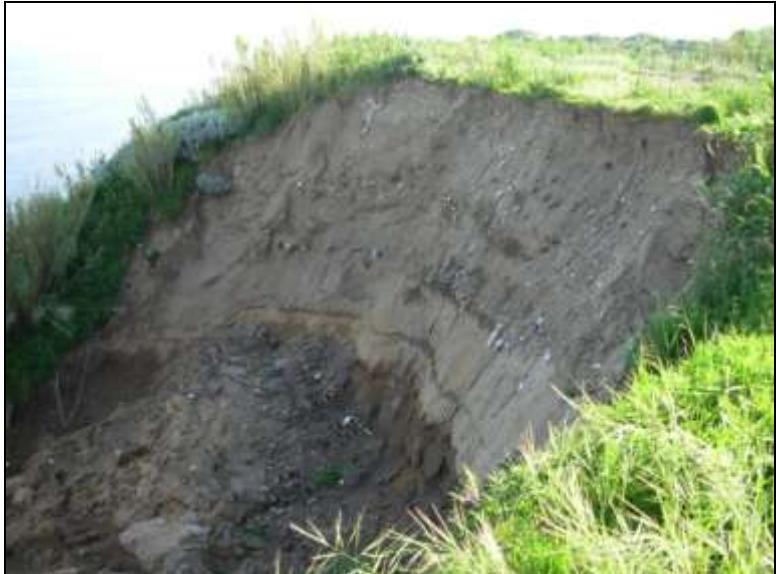
Landslide crown

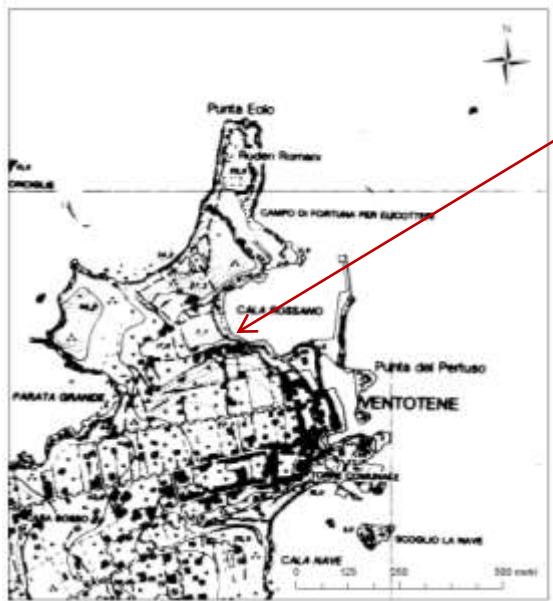
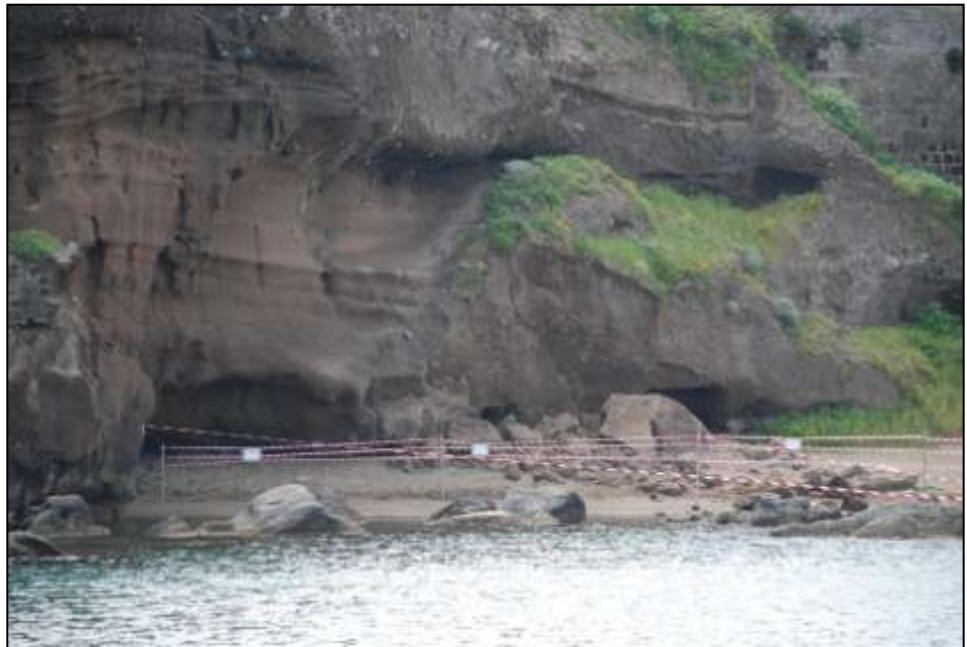
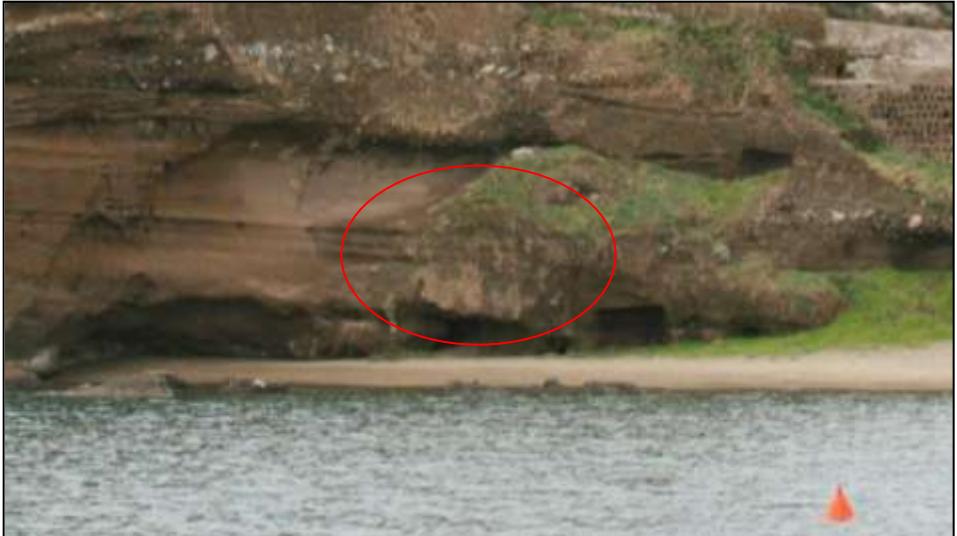
Cala Rossano,  
20 April 2010

before (*photo: Technical Office of Ventotene Municipality*)

after

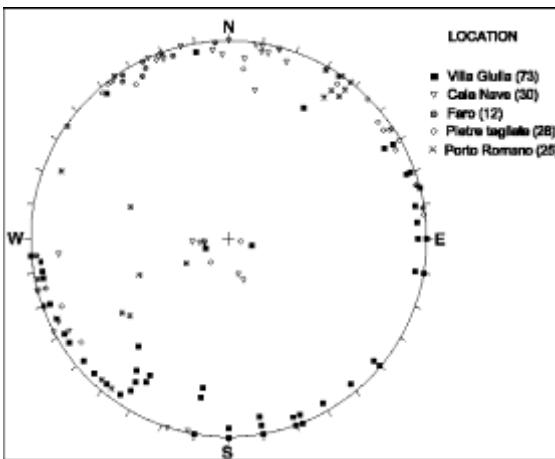
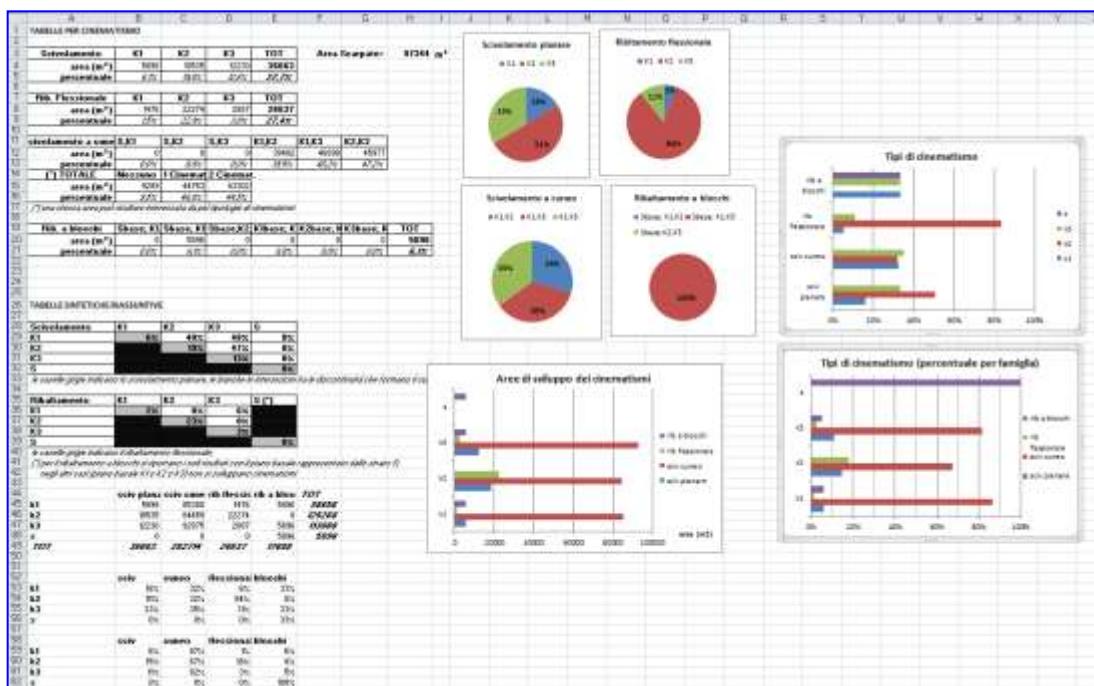
## Matheson test (1983)

Four failure mechanisms:

Wedge failure

Block toppling

Planar sliding

Flexural toppling

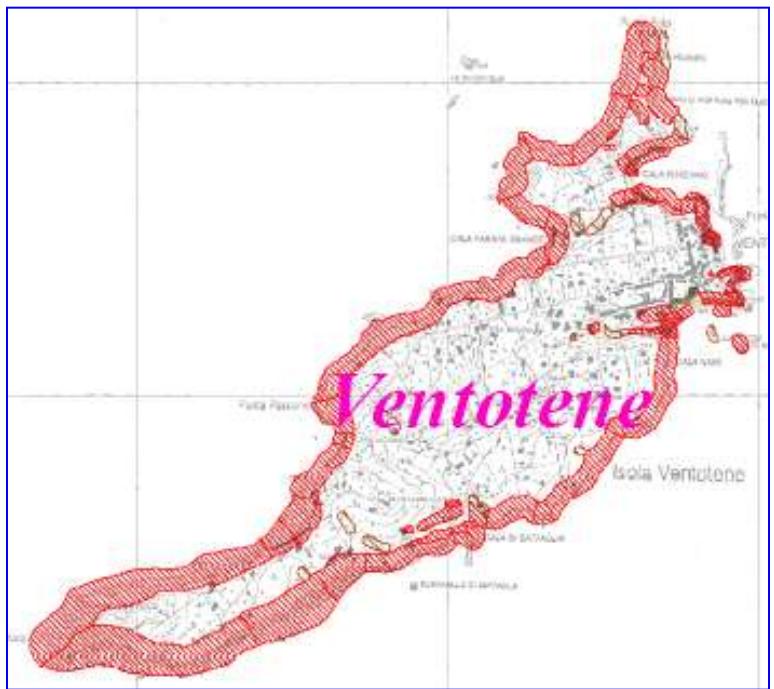
Susceptibility map of the Basin Authority (2013 update)
